Service Bulletin

Model: UXV 500/500i/700

SB# 17002

Subject: Bevel gear replacement

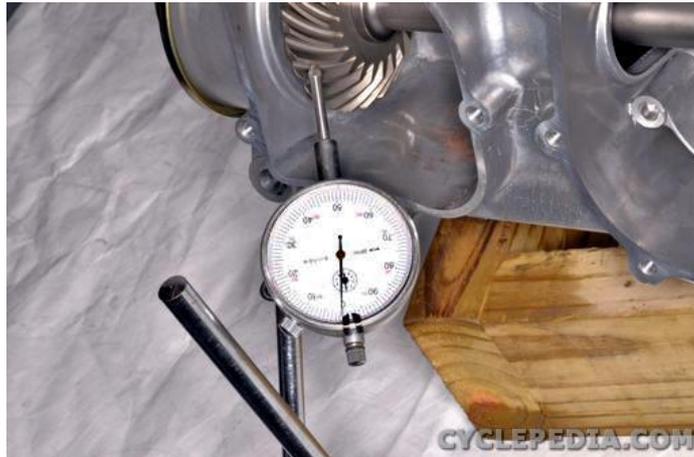
- 16) Fit new shims, bevel gears, centre driveshaft and driveshaft adapter. The nominal shim is 0.85mm both sides.
- 17) Fit and torque both bevel gears into place, **DO NOT STAKE THE NUTS** yet. Check the backlash from the centre of the tooth on the driven gear as shown below. Replace shims as needed to achieve a backlash of 0.03-0.15mm and a contact pattern central on the teeth.

- 18) Stake the locknuts in place and refit the bevel gear cover.
- 19) Replace oil filter.
- 20) Refit engine, drive shafts and diffs as needed.
- 21) Refill with oil and water.
- 22) Test drive.
